All Saints' Church, Walsoken  
Renovation Project

Title: Tree Survey 23 March 2023

# **Tree report**

**All Saints Church  
Walsoken  
Wisbech  
PE13 3RA**

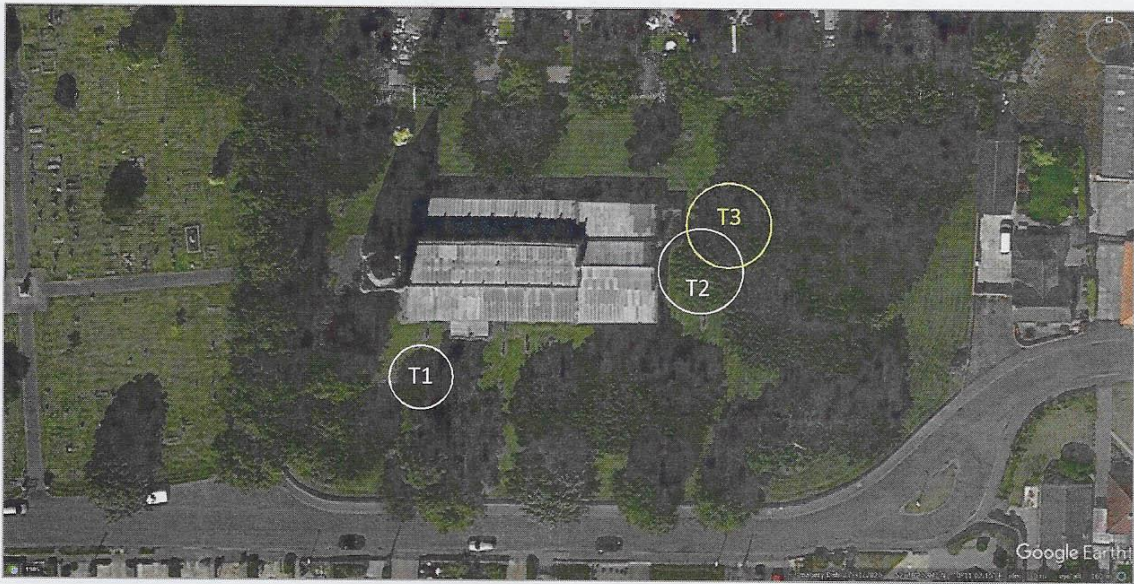
Figure 1, the site and the trees
